**DEPARTMENT OF TRANSPORTATION**

Contract #: 04-0120F4Cty: SF/ALA Rte: 80 PM: 13.2/13.9File #: 1.28**WELDING INSPECTION REPORT****Resident Engineer:** Casey, William**Address:** 333 Burma Road**City:** Oakland, CA 94607**Report No:** WIR-028158**Date Inspected:** 11-Aug-2012**Project Name:** SAS Superstructure**OSM Arrival Time:** 700**Prime Contractor:** American Bridge/Fluor Enterprises, a JV**OSM Departure Time:** 1530**Contractor:** American Bridge/Fluor Enterprises, a JV**Location:** Job Site**CWI Name:** As noted below.**CWI Present:** Yes No**Inspected CWI report:** Yes No N/A**Rod Oven in Use:** Yes No N/A**Electrode to specification:** Yes No N/A**Weld Procedures Followed:** Yes No N/A**Qualified Welders:** Yes No N/A**Verified Joint Fit-up:** Yes No N/A**Approved Drawings:** Yes No N/A**Approved WPS:** Yes No N/A**Delayed / Cancelled:** Yes No N/A**Bridge No:** 34-0006**Component:** Tower / OBG**Summary of Items Observed:**

Quality Assurance Inspector (QA) William Clifford was at the American Bridge/Fluor (ABF) job site at Yerba Buena Island in California between the times noted above in order to monitor Quality Control functions and the in process work being performed

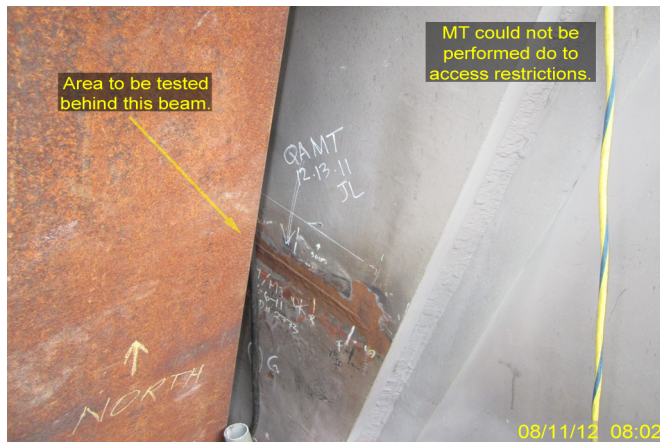
Approximately 7:30am QA Lead Daniel Reyes instructed this QA to perform Magnetic Particle Testing (MT) of a repair area on the West Jacking Block. Upon arrival, this QA determined that due to obstructions (a bolted in place beam) MT could not be performed at this time. This QA telephoned Mr. Reyes and informed him this access restriction. Mr. Reyes told this QA that testing would be attempted at a future time when the obstruction had been removed.

Please see pic below for visual representation of the obstruction.
